INSPECTION REPORT

Client: Brad Caraway **Address:** 10965 Cleveland KC, KS 66109 **Performed:** 10-21-08 @ 12:00pm
Weather/Temperature: Cloudy/50 **Delivered:** 10-22-08 @8:00am **Billed:** By Mail
Agent: Brandon Decker – Reece and Nichols **Agent Phone:** 913-299-1600
Inspector: Doug Geyer – All N One Home Inspections LLC **Inspector Phone:** 913-915-7103

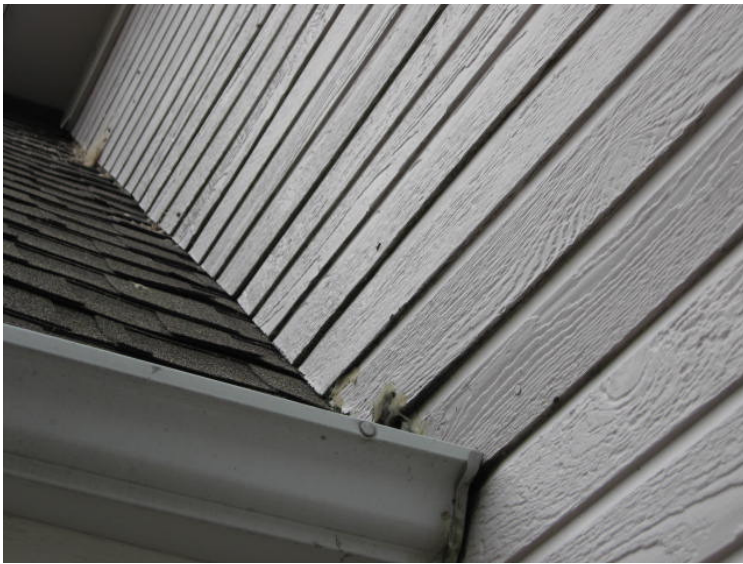
11. Primary Roof Covering- There are shingles on the roof that are damaged and missing. There is no sealant over the nails that secure the vents to the roof. The siding is touching the shingles in front on the west side of the garage. It is recommended to replace the damaged shingles, and replace the siding.

Siding buckled and too close to shingles.

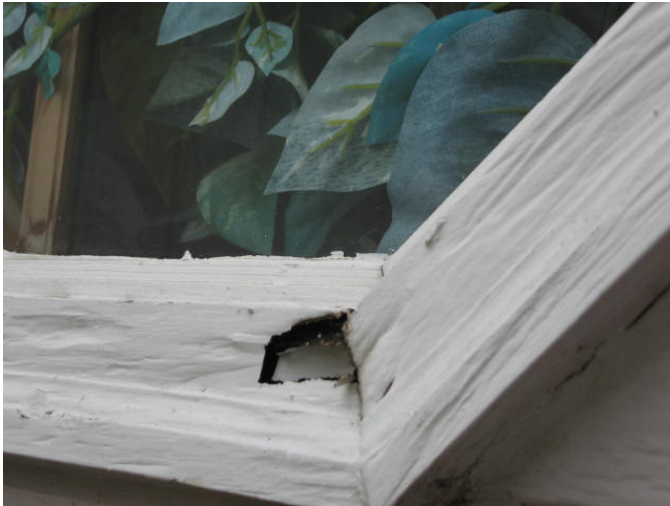
15. Exterior Window Trim- There is rotted trim on every window around the house. It is recommended to replace all rotted wood trim as needed.
16. Garage Area- The automatic reverse features are raised too high off the ground. It is recommended to lower the features to within 6" of the ground. The ceiling is damaged from plumbing lines leaking. The master bathroom shower is leaking onto the ceiling, and needs to be repaired. It is recommended to repair all plumbing lines to assure no leaking onto the ceiling.

Rotted window trim that needs to be replaced.

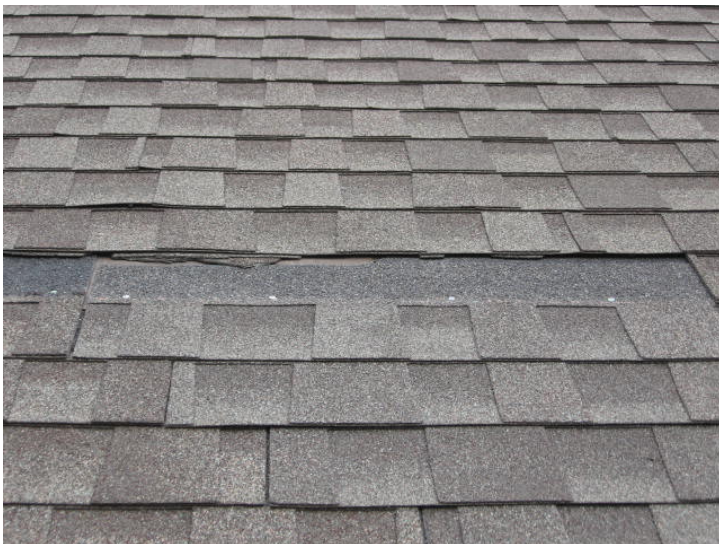
Missing shingle on roof that needs to be replaced.

Style gable
Observation Method ladder
of Layers 1
Est. Life Remaining 8-12 years
Shingle/Covering Type Composition
Comment: replace damaged shingles

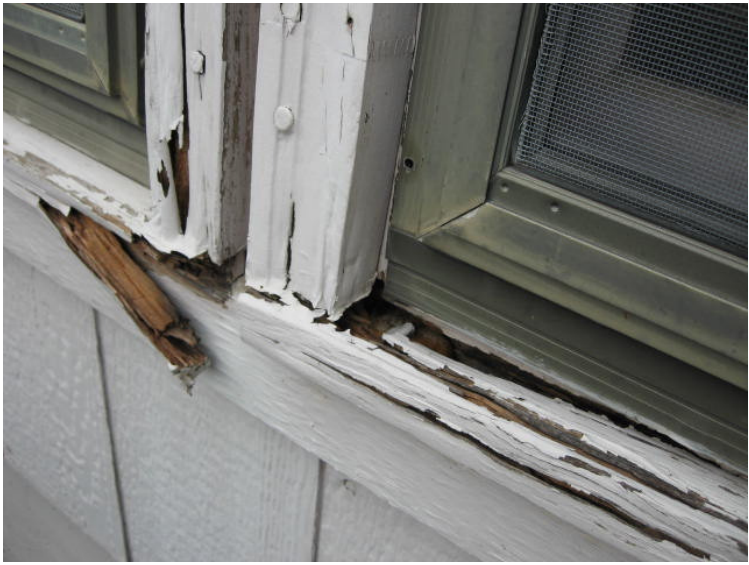
Rotted window trim that needs to be replaced.

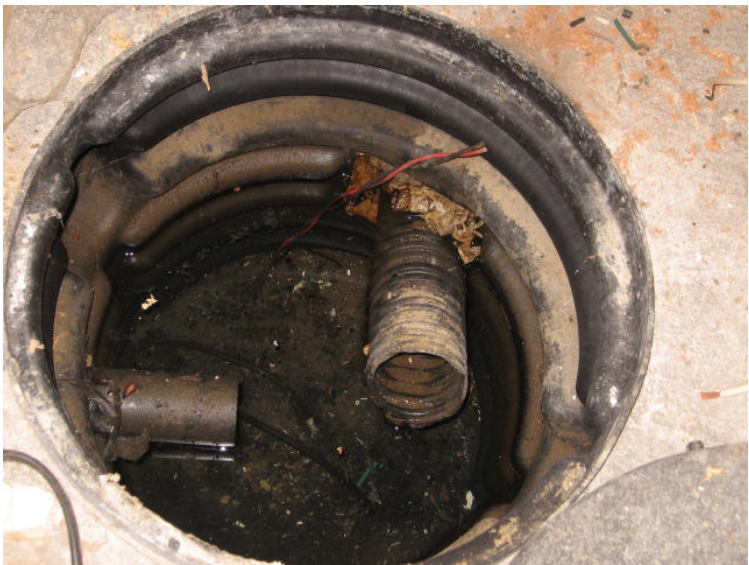
U Sump Pump
 Comment: no pump installed in pit

No sump pump installed in pit in basement.

21. Sump Pump- There is no sump pump installed in the pit in the basement. There is water in the pit. It is recommended to install a sump pump.
22. House Plumbing- The house is plumbed with Polybutylene Plumbing, or PB 2110. This type of plumbing has been documented as being problematic and may leak at the joints. It is recommended to contact a qualified plumbing contractor to obtain more information about this product. There is a class action lawsuit against this type of plumbing.

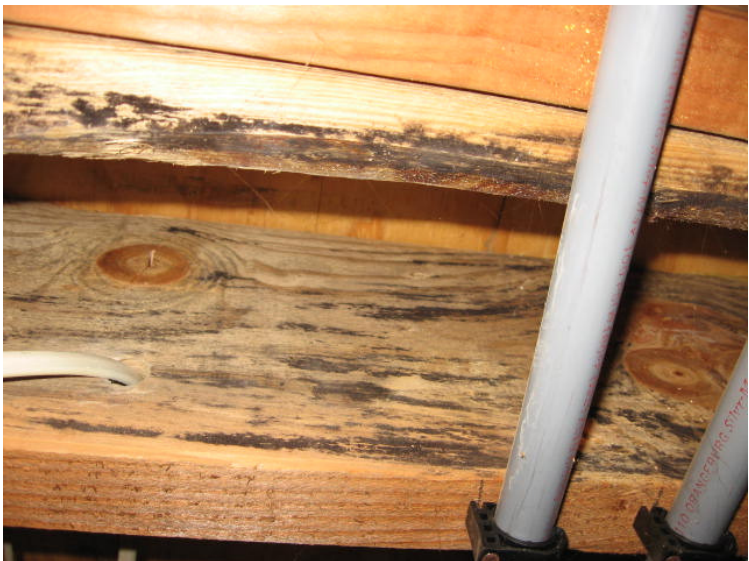
20. Interior Floor Joists and Wall- There is mold on the drywall under the basement sink, and on a few floor joists near the furnace. It is recommended to have the test inspected for the presence of mold, and remove as needed.

Mold on floor joists in basement.

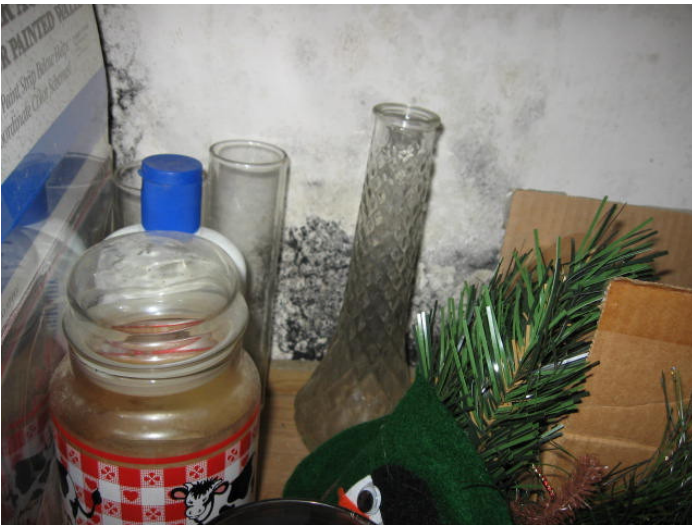
27. Basement Bathroom- There is mold on the drywall under the sink. There is no heat source in the bathroom. It is recommended to install a heat source.

Mold on drywall under basement bathroom sink.

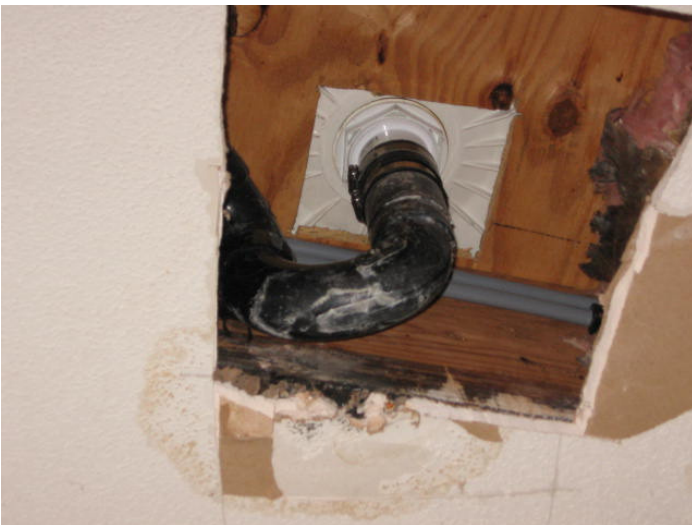
28. Fireplace- There is creosote built up in the flue that needs to be cleaned. It is recommended to clean the flue.
29. Interior Ceiling- There is evidence of water leaking in the family room, and in the garage. The areas are dry now, but should be monitored for future leakage.

Master bathroom shower leaking into garage.
