INSPECTION REPORT

Client: Milo and Anna **Address:** 11708 Johnson Dr. Shawnee, KS 66218 **Performed:** 02-28-09 @ 10:30am
Weather/Temperature: Snow/25 **Delivered:** 03-01-09 @8:00am **Billed:** On Site
Agent: Cheri Kraft – Re Max **Agent Phone:** 913-709-8485
Inspector: Doug Geyer – All N One Home Inspections LLC **Inspector Phone:** 913-915-7103

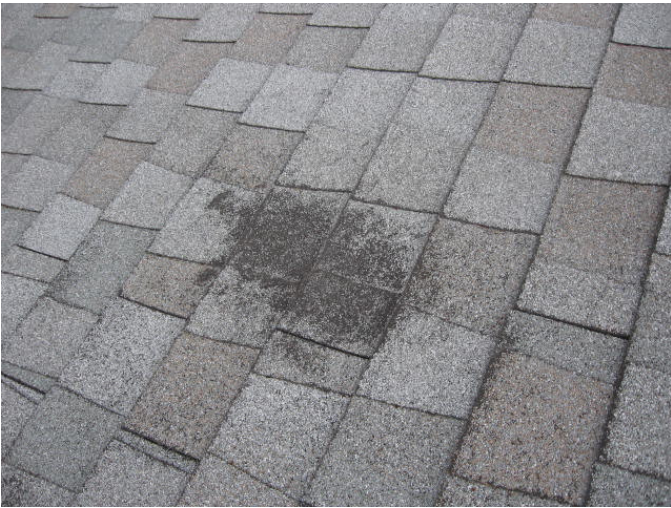
Damaged shingles on roof.

10. Exterior Trees and Vegetation- The trees and vegetation need to be trimmed away from the house to assure they do not damage the house.
11. Primary Roof Covering- There are damaged shingles on the west side of the roof that need to be replaced. The flashings around the vents and fireplace need to be sealed and secured to the roof.

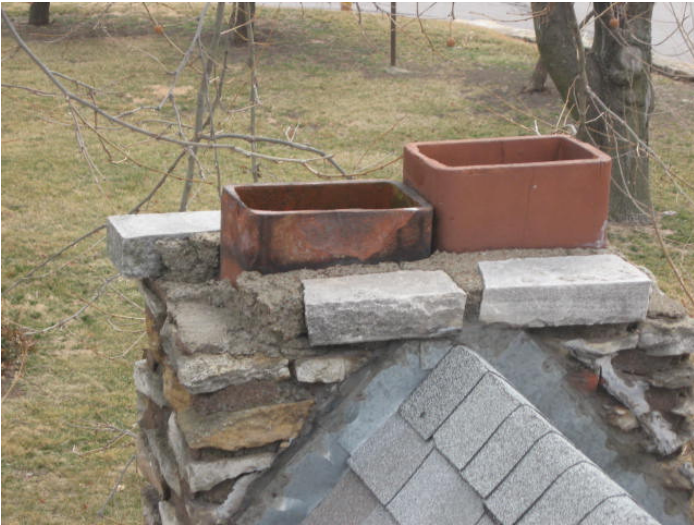
Damaged crown on fireplace and no flue caps.

7. Exterior Fireplace- The crown is damaged, and needs to be repaired. There are no flue caps installed. It is recommended to install flue caps. Suggest service by a qualified chimney repair specialist.

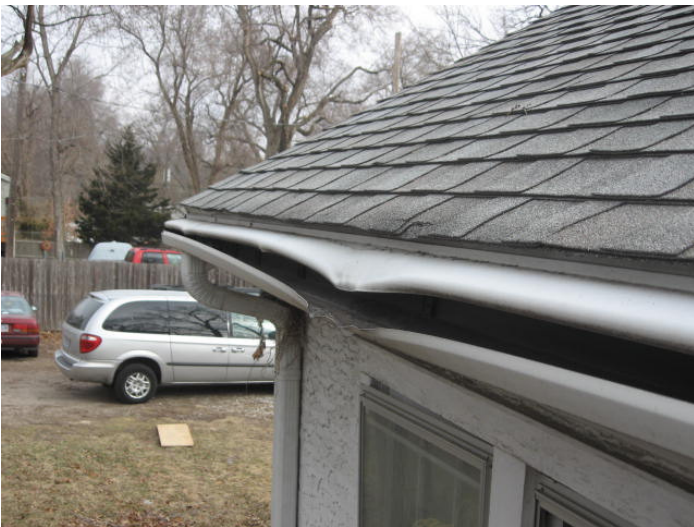
Damaged gutter.

8. Exterior Gutters- The gutter is damaged on the west side. It is recommended to repair the gutters to assure proper drainage of water.
9. Exterior Foundation Wall- There are cracks on the west wall that need to be sealed and repaired. Suggest service by a qualified foundation repair specialist.

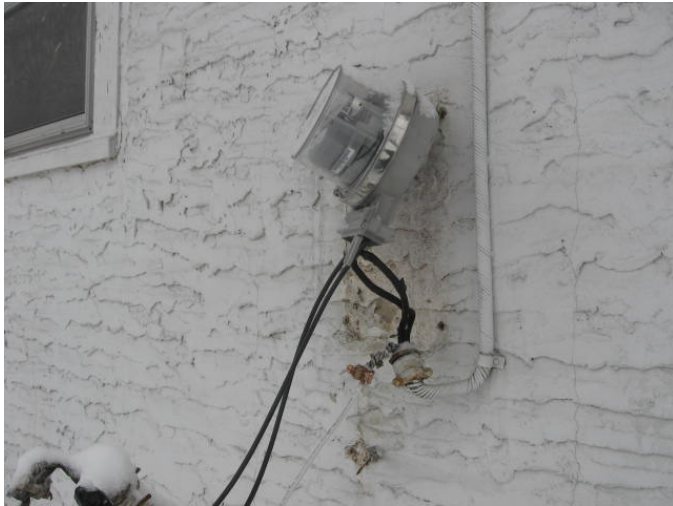
60-amp box not secured to house.

3. Exterior Electrical Service Entrance Wires- The wires to the house are 60-amp wires, and not secured to the house. The breaker in the interior box is a 200-amp breaker. It is recommended to upgrade the wires to the house to 200 amps. Suggest service by a qualified electrical contractor.

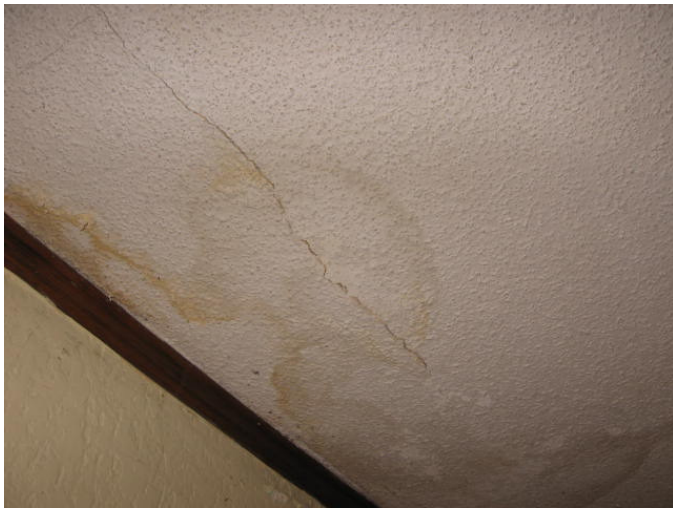
Water damage on ceiling in dining room.

24. Interior Walls and Ceilings Water Damage- There is evidence of water leaking in several areas in the house. The dining room, the bedroom closets, and the living room. The areas appear to be dry now, but should be monitored for future leakage. It is recommended to repair the areas.

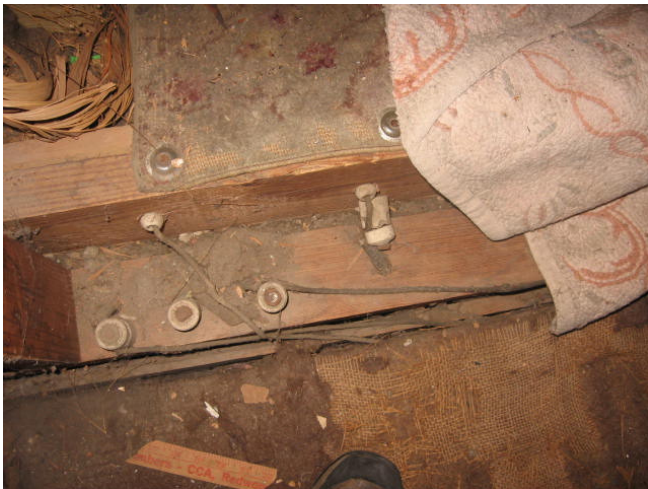
Knob and tube wiring in attic.

5. Electrical Wiring- There is active knob and tube wiring that was observed in the attic and the basement. This is an older type of wiring system with a hot and neutral wire wrapped with insulation. The insulation becomes brittle and the wires are exposed. It is recommended to contact a qualified electrical contractor to inspect the wiring and make repairs or replacement as needed. It is also recommended to contact your insurance provider to obtain information about coverage on a house with knob and tube wiring.

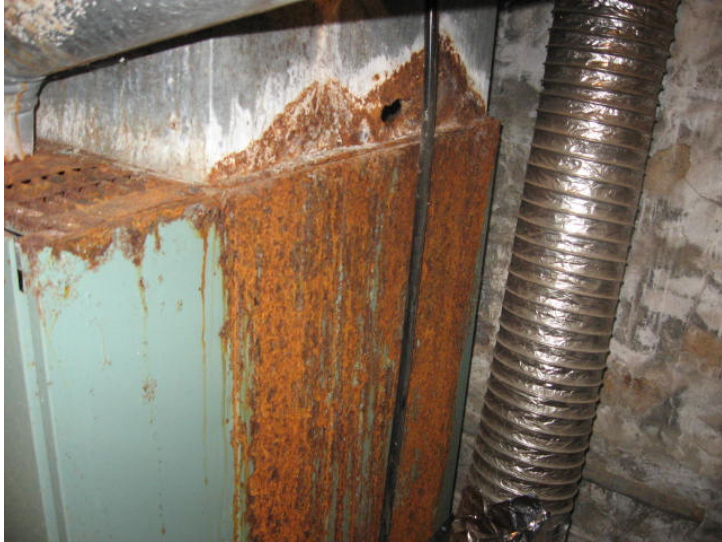
Rust on hot water heater.

14. Hot Water Heater- The hot water heater is old, and past its life expectancy. It is recommended to replace the hot water heater.
15. Furnace Gas Line- The gas line to the furnace is not a solid, black gas line. It is recommended to remove the gas line, and install a solid, black gas line.

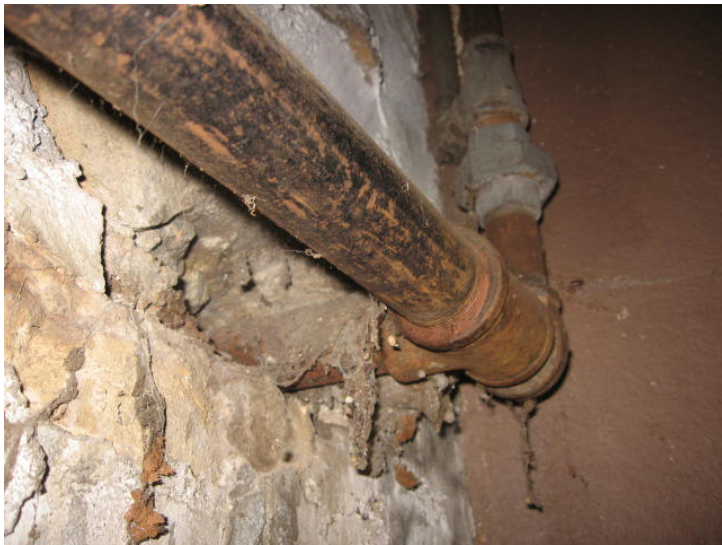
Gas line entering house below grade.

6. Gas Line- The gas line enters the house below grade and through the foundation wall. The wall can shift and damage the gas line. There is a gas odor near the main gas line on the west wall. It is recommended to move the gas line to enter the house above grade, and repair the leak. Suggest service by the gas company.

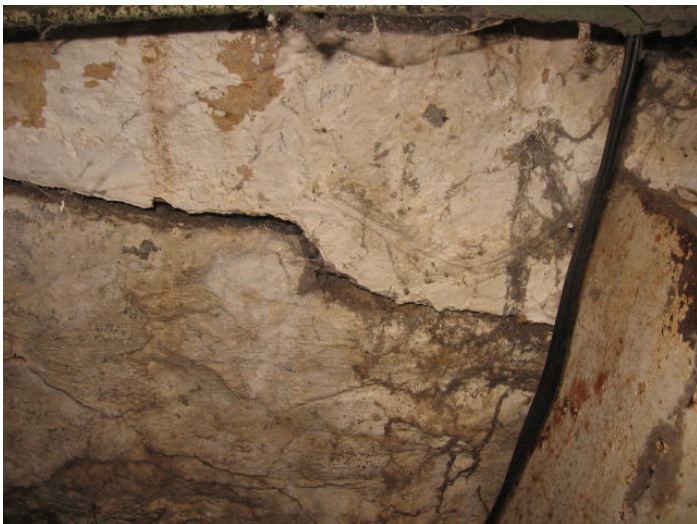
Crack on foundation wall.

18. Air Conditioner- The unit could not be tested because the outside temperature was too cold.
19. Interior Foundation Wall- There are large, vertical cracks on the front wall, and horizontal cracks on the east and west walls. There is evidence of inward movement on the west wall. There is evidence of water entry in the basement. It is recommended to have the house inspected by a structural engineer, and make repairs as needed.
